BUENA VISTA RANCHERIA
BAND OF ME-WUK INDIANS
1418 20TH STREET
SACRAMENTO, CA 95811
916-491-0011

Erosion issues Buena Vista Peaks tributaries to the western stream

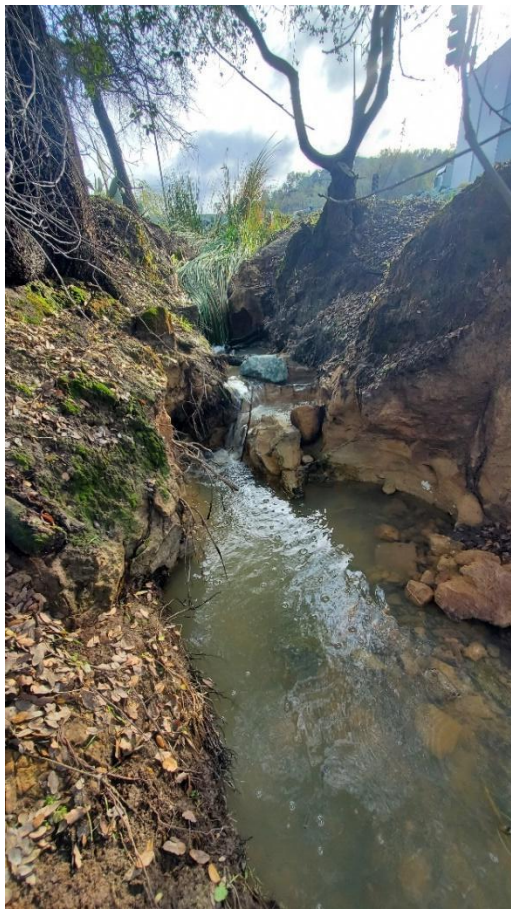
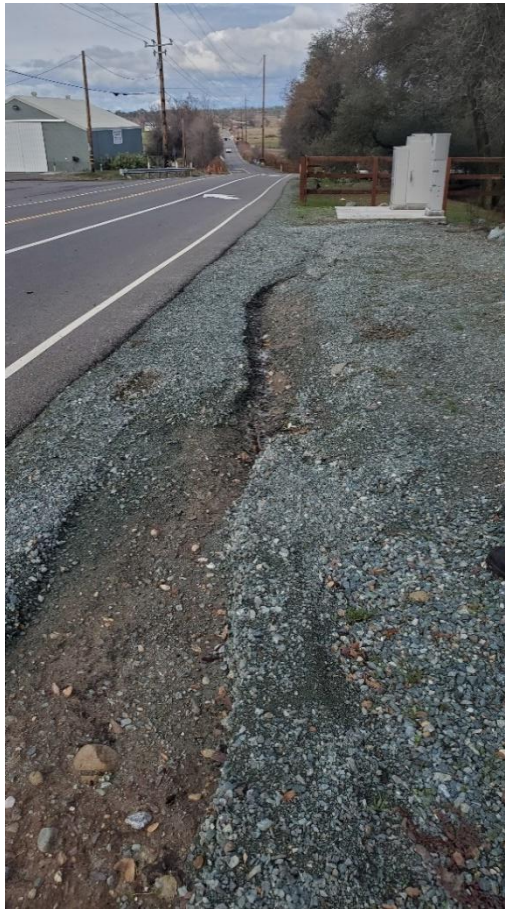
Erosion caused by stormwater runoff from storm in January 2023

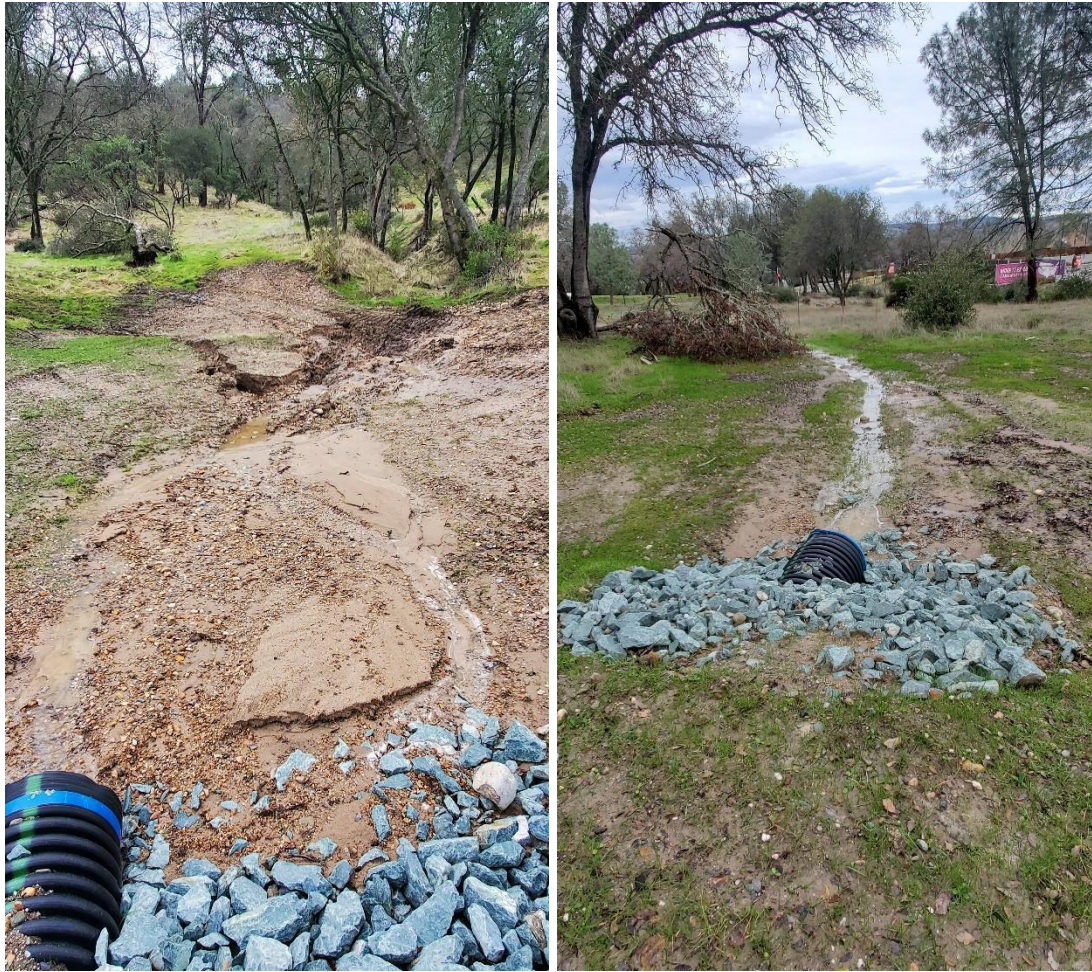
Eroding tributary from BV Peak property that feeds into the western stream during storm events. This is a candidate for stormwater control bioswale project. Photographed January 2023

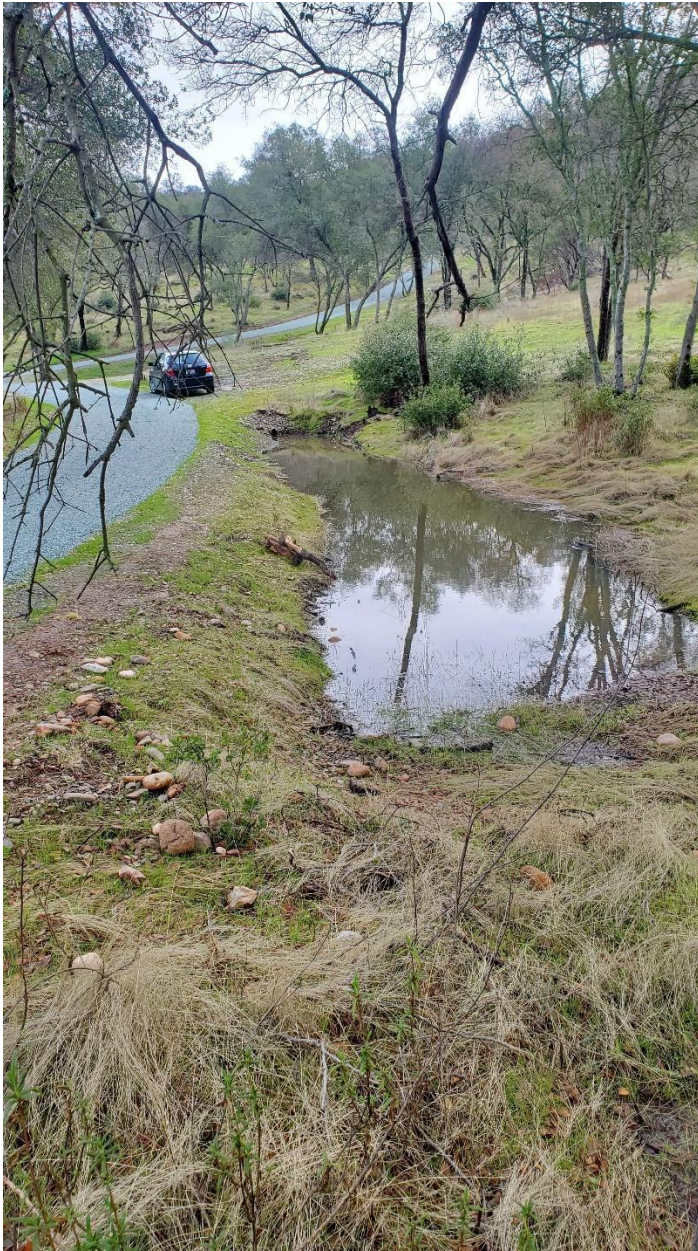
This is a swale on the BVR Peaks Property that flows into the western stream. This is a stormwater control project candidate that could be restored to improve functional stormwater capacity and incorporate native vegetation.
